Manhole Inspection Summary

Manhole # S11EE_029MH

Location Address: **REAR OF 3000 BELMONT AVE** Cross Street: **LONGWOOD ST**

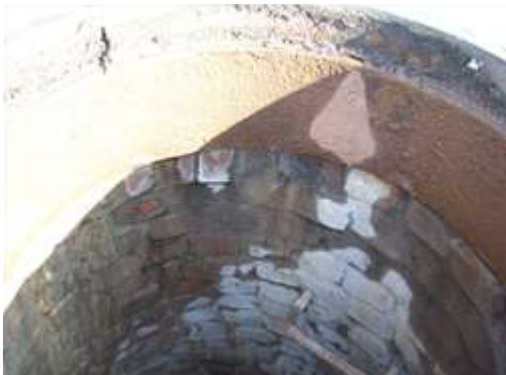
Defect 3

Corbel Material: **Brick** ☐ Parged Type: **Concentric/Eccentric**

Condition: ☐ Sound ☒ **Cracked** ☐ Root Intrusion ☒ **Loose Brick** ☐ Deteriorated

CRACKED CORBEL-LOOSE BRICKS

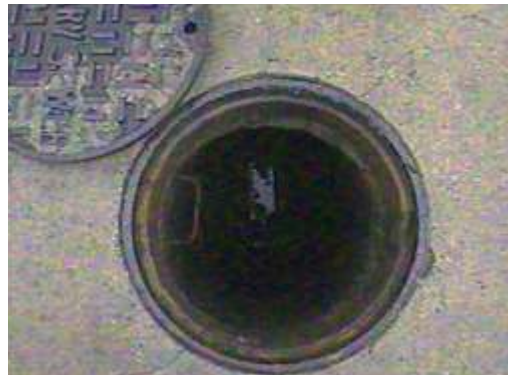
Defect 4

Frame Offset: **1** (in.) Condition: ☒ Sound ☐ Cracked ☐ Leaks

FRAME OFFSET

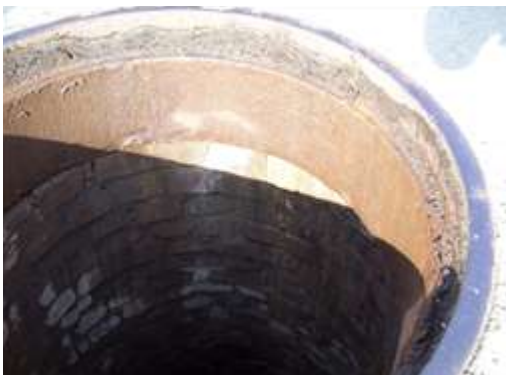
Defect 2

Chimney / Frame Adjustment ☒ Exists Material: **Brick** ☐ Parged Height: **0** (in.)

Condition: ☐ Sound ☒ **Cracked** ☐ Root Intrusion ☐ Loose Brick ☐ Deteriorated

CRACKED FRAME ADJUSTMENT

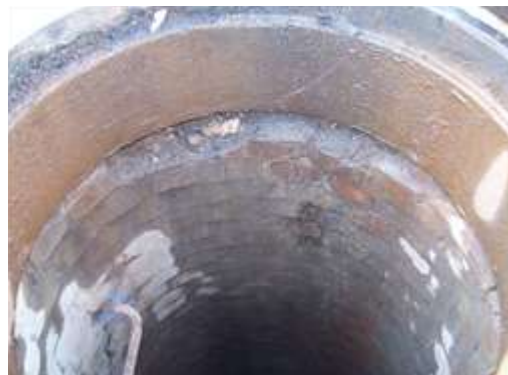
Defect 1

Infiltration: ☐ None ☐ Joint ☐ Cracks ☐ Mortar ☐ Roots ☒ **Wall**

CRACKED CORBEL-INFILTRATION

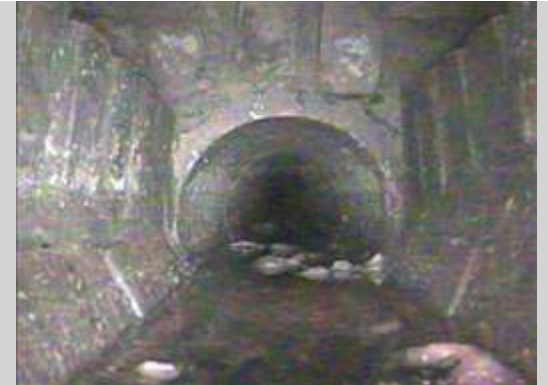
12 O'Clock Outflow

Pipe Height: (in.) Direct
Pipe Material: **Clay** ☐ Pipe Lined
Invert Depth: **9.92** (ft.) Flow Characteristics: **Slow**
Deposits: ☐ None ☐ Mud ☐ Sludge ☒ **Debris** ☐ Grease
Silt Depth: **2** (in.) Deposits Extent: **Light**
Infiltration: **None** Pipe Seal Cond: **Sound**

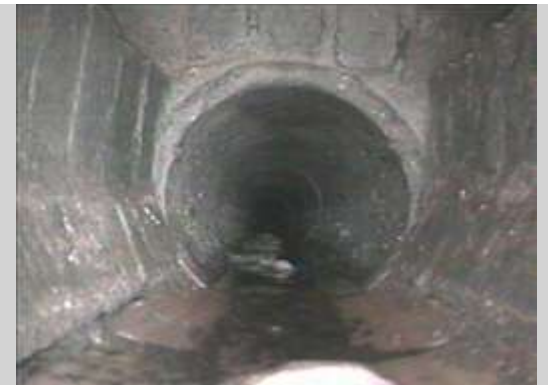
6 O'Clock Inflow

Pipe Height: (in.) Direct
Pipe Material: **Clay** ☐ Pipe Lined
Invert Depth: **9.89** (ft.) Flow Characteristics: **Slow**
Deposits: ☐ None ☐ Mud ☐ Sludge ☒ **Debris** ☐ Grease
Silt Depth: **1** (in.) Deposits Extent: **Light**
Infiltration: **None** Pipe Seal Cond: **Sound**
